## PRELIMINARY REPORT:

Case No. 2026-CV-1048

A written preliminary report regarding the case above  
including the facts, cause, and findings based on professional training, knowledge,  
experience, regulations, and industry best practices.

September 16, 2026

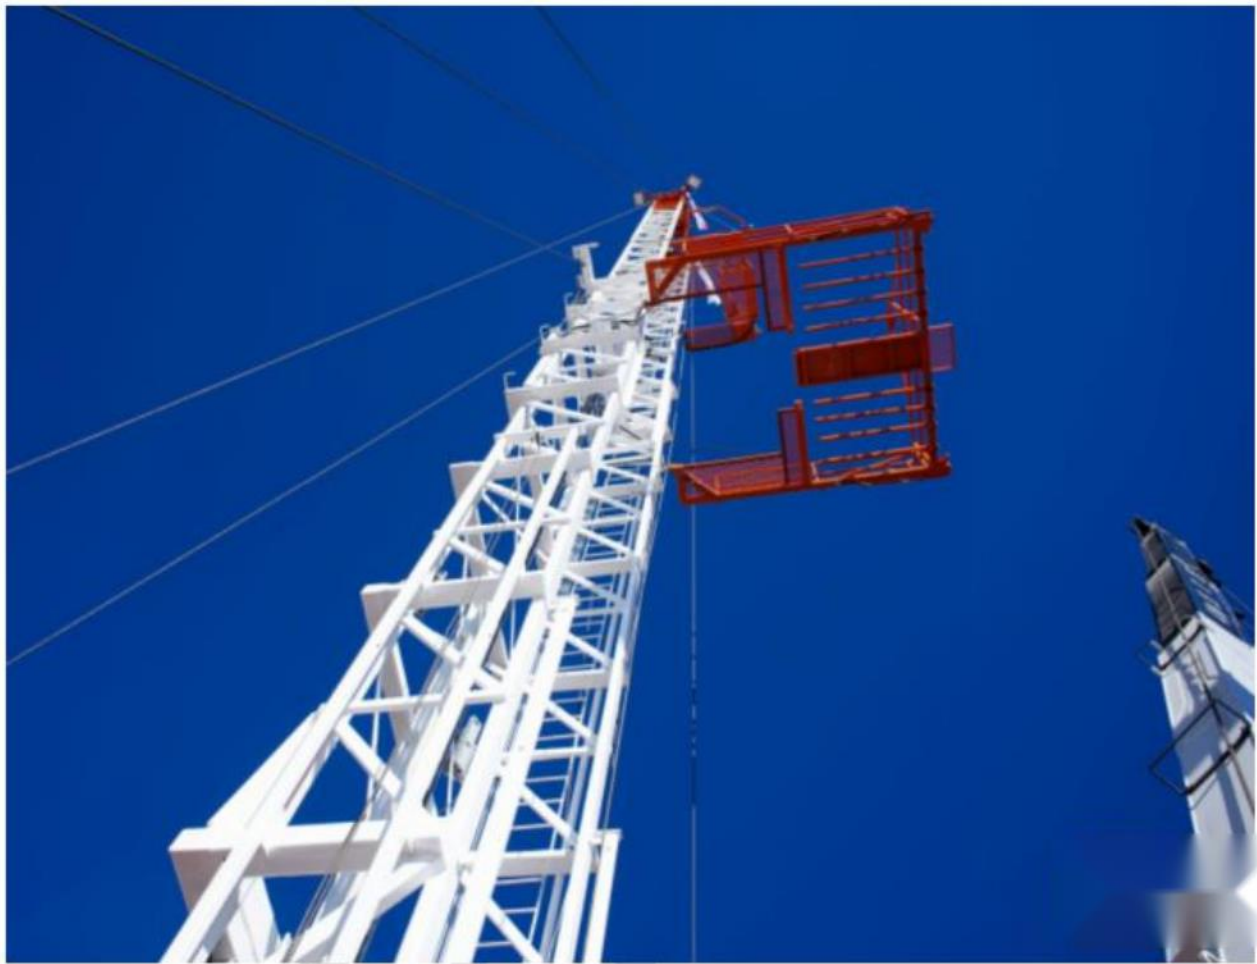
Figure 4: Basket<sup>35</sup>

A one-minute video<sup>39</sup> taken onsite at the time of the incident shows the mast swaying, the pipe against the derrick begin to topple, a cable popping, and the mast collapsing pulling the subject rig over with it. Three workers were in the basket on the mast when it collapsed.
